TUCKER FREE LIBRARY

HISTORIC BUILDING REPORT

31 Western Avenue Henniker, NH 03242

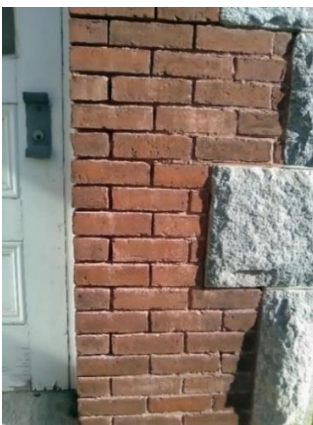
Image 74, J-Room Entry

C. Mortar is missing along the southwest corner beside the J-Room entry door. Existing mortar in these joints has deteriorated to the point of a sand-like quality (Image 74).

Recommend pointing in areas where missing mortar is present. New mortar shall match existing color and thickness. Joints between granite stairs should be professionally inspected, if the sealant has torn or lost elasticity than existing material should be removed, with new sealant installed.

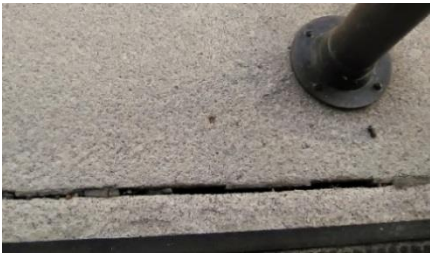
D. Mortar is missing between the landing and steps at the south entry, allowing moisture an opportunity to widen gap over time. (Image 75).

Image 75, Gap in granite at south entry

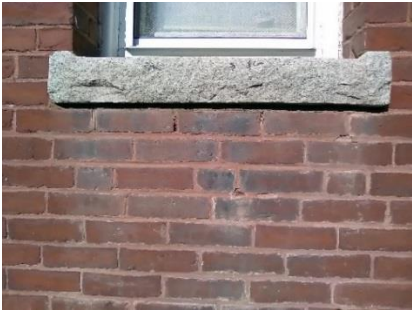
Image 76, Efflorescence below granite sills

Efflorescence, staining, and deteriorated mortar visible along the north and west elevations. This could be due to drainage from air conditioning units placed in window openings, moisture is present which has causing the salts to surface and leaching out of the brick.

Iron staining on either side of the granite entry below the decorative lighting fixtures (Image 76). This could be cause by water infiltration at the exposed opening prior to the reinstallation of the new lights, and leaching out the joints

Recommend areas be professionally cleaned per industry standards with dry brush, mild detergent, and natural water. Abrasive efforts such as sandblasting is not recommended.

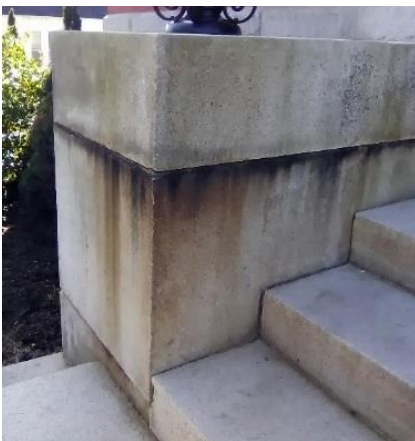
Image 77, Stone staining at entry

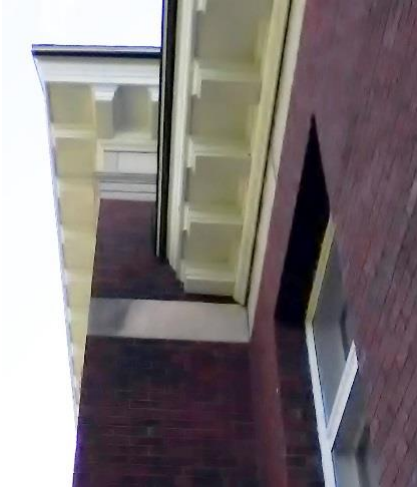
Image 78, Unknown discoloring

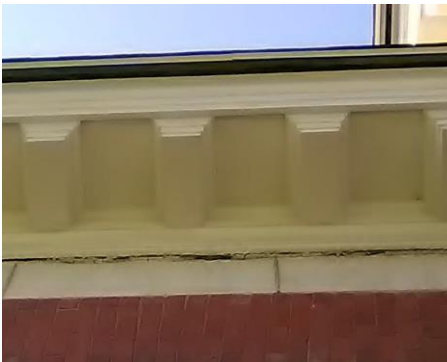
Image 80, Cornice trim

Aged and dried sealant at joints between stone freeze and cornice trim. This condition could allow insects and moisture into the adjacent wood causing rapid deterioration

- A. Areas of separation and signs of minor rot between the cornice and masonry freeze are visible at the north, west, and south elevations. This could create a water infiltration condition and should be repaired (Image 80).

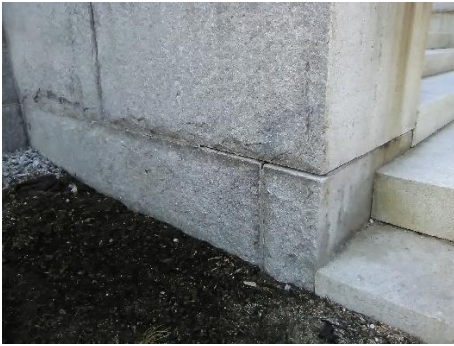
Image 81, Granite grouting

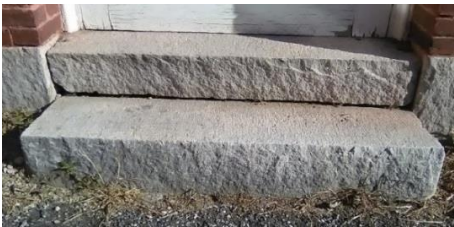
Image 82, Shifted granite steps

- A. Grout replacement at granite blocks (Image 81).
- B. Granite steps leading to the entry to the J-Room have shifted. This has created gaps, and missing mortar joints (Image 82). Shifting of the granite steps has also led to a gap at the head of the J-Room entry door frame (Image 83).

Recommend the remove existing stone steps and retaining wall at areas of shifting. Preparation of sub-grade with suitable structural fill, compacted and re-set level. Use of backer rod and silicon sealants to reduce water infiltration and separation to mitigate further shifting.

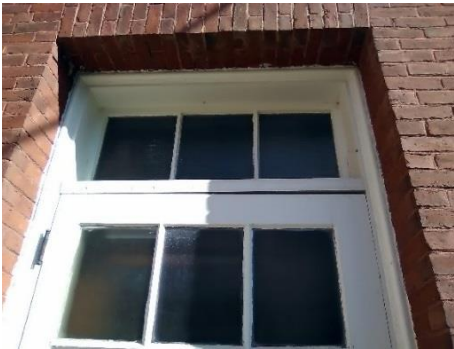
Image 83, Gap at J-Room Door

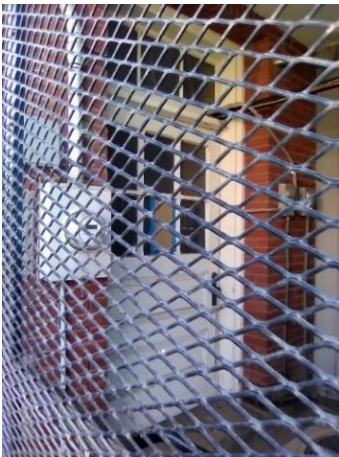
Image 86, Missing glazing boiler room door

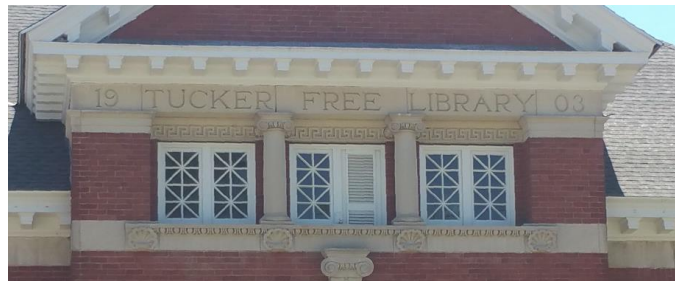
Damaged window sash replaced with louver before repairs.

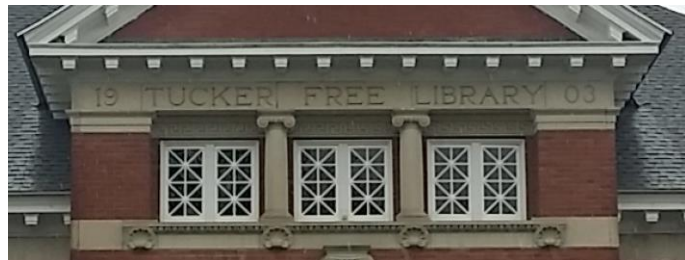
After preservation treatment by Dave Bowers

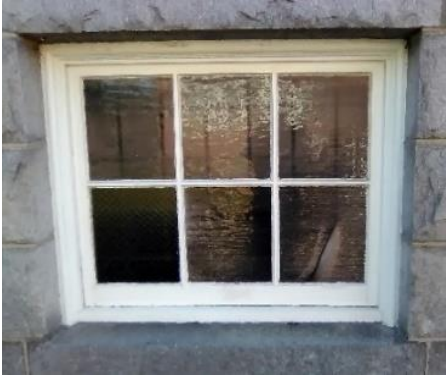
Image 87, Damaged and mixed glazing

Repair existing glazing. Replace in kind

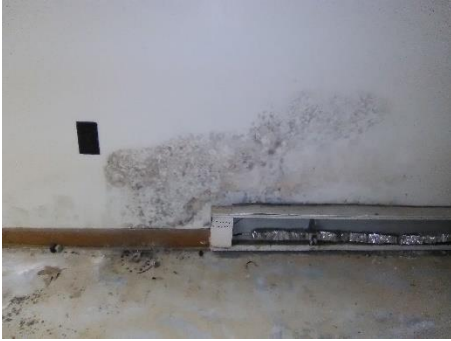
Image 88, Mold at Sub-basement

The lowest level sub-basement has evidence of water infiltration. Potentially through the stacked stone foundation. The lack of ventilation in the space along with moisture have created a damp environment and musty smell.

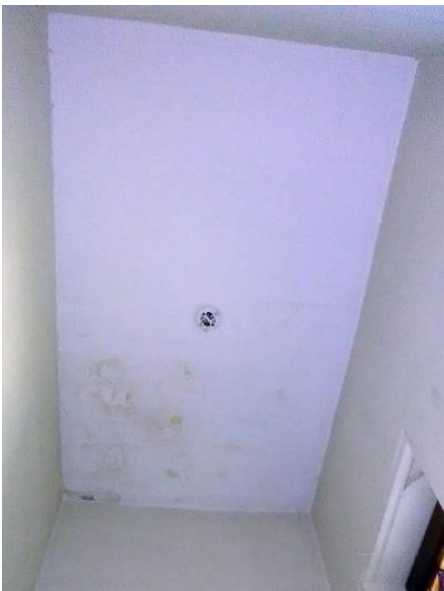
Image 95, Water staining at bathroom

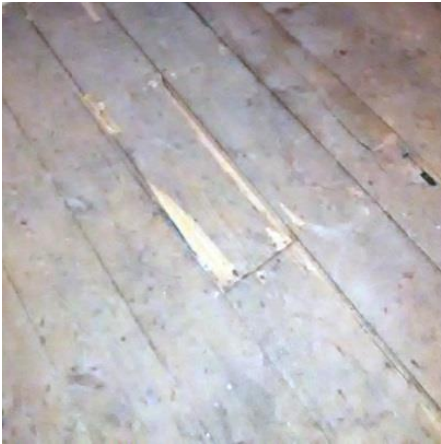
Image 97, Minor damage at Floorboards

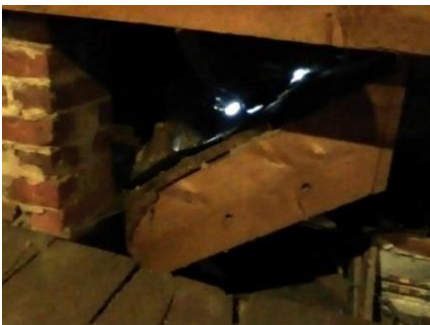
Image 98, Daylight at chimney flashing
