Tucker Free Library

Architectural Feasibility

Study Report

March 2019

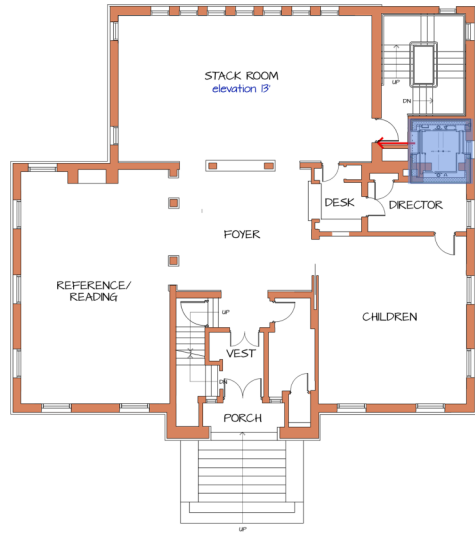
5
TUCKER FREE LIBRARY
Elevator Location Options ♦ December 2018

Option 5:
New elevator placed in side
building on West side of
building adjacent to stair.

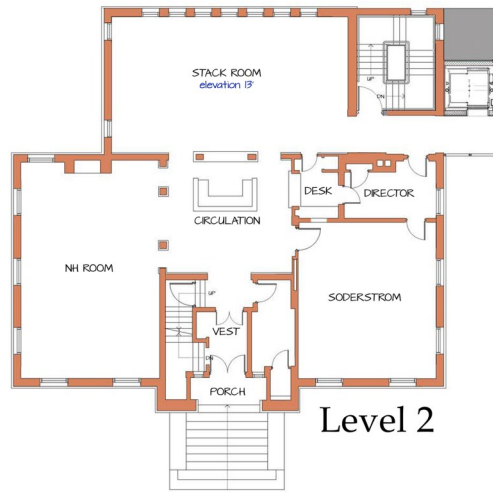
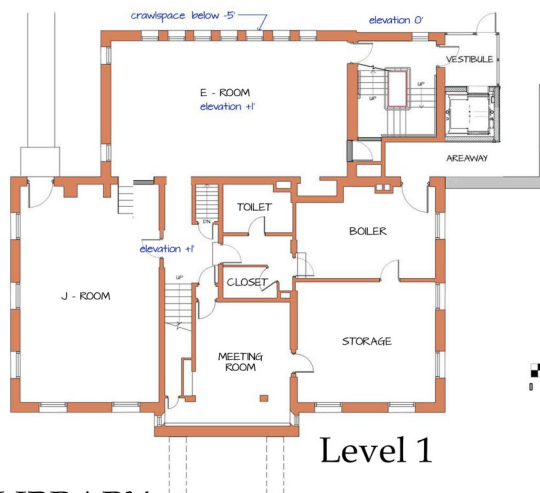
Preferred Option:
New elevator placed outside
building on West side of
building.

- 1. Retains existing egress stair
- 2. Maintains current rear entry location.
- 3. Will connect to each floor.
- 4. Minimal impact of library operations.
- 5. Better connections with school.

- 1. Potentially more costly.
- 2. Will require exterior walkway reconfiguration.

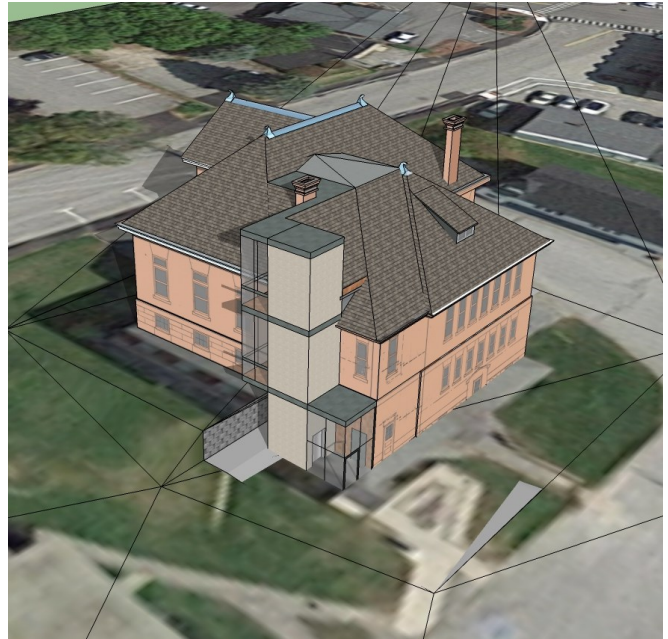
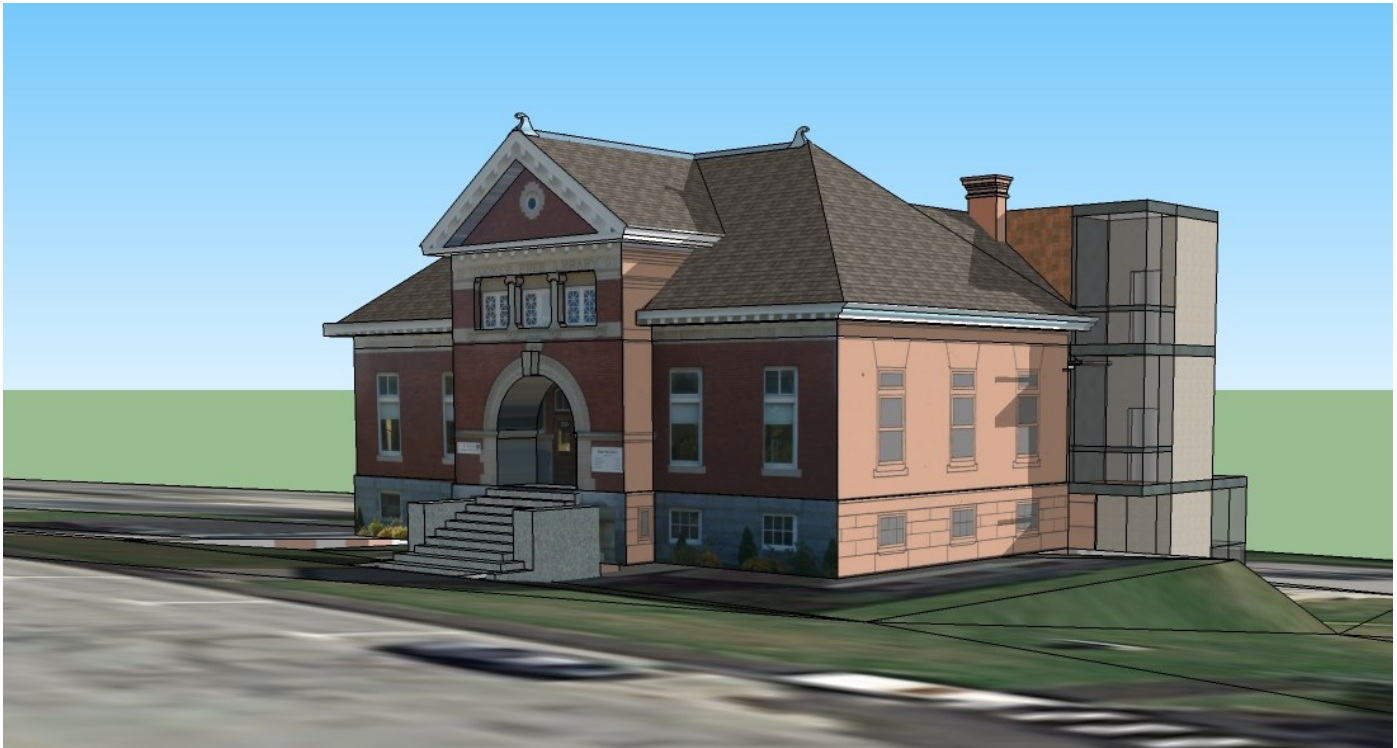
Preferred Option:
New elevator placed outside building on
West side of building.

This massing model is not a final design
