TUCKER FREE LIBRARY

HISTORIC BUILDING REPORT

31 Western Avenue Henniker, NH 03242

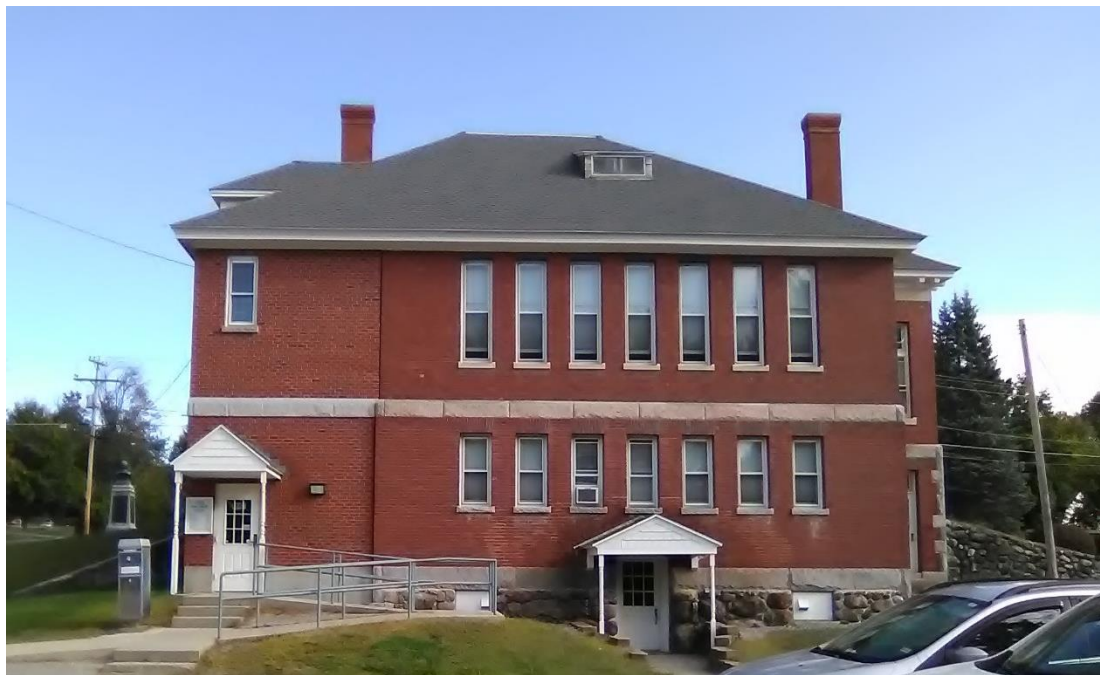
Image 14. South elevation. Note the addition was built in 1991 on the southwest corner. Facing north, photo taken: 10/2019.

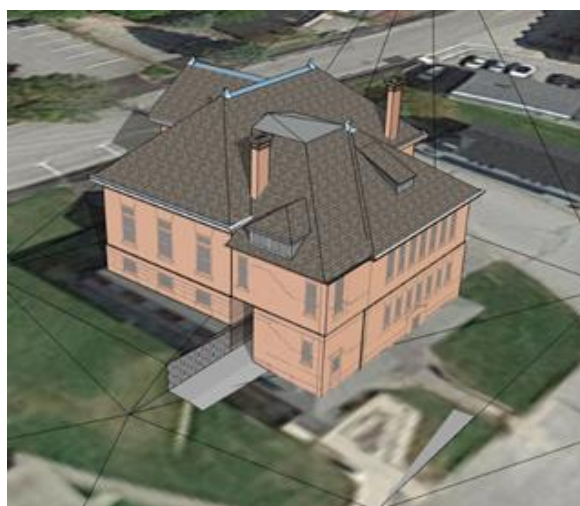
Image 28, Existing South West Isometric View

The community has a long-standing commitment to maintaining the Tucker Free Library by generously supporting projects. However, some past decisions have not adequately attended to preservation priorities. For example, SMP noted in their 2019 feasibility study that the 1991 addition does not meet the Secretary of the Interior’s Standards for Rehabilitation. “When the 1991 stair addition was added the approach was to minimize its appearance by tucking it into the back corner, cladding it with matching brick veneer and blending together the roofs.”²⁸

The proposed future elevator addition will address the shortcomings of the 1991 addition by enclosing the existing stairway with a new architectural element that has clearly different styling than the original while respecting the materials, form and overall scale.

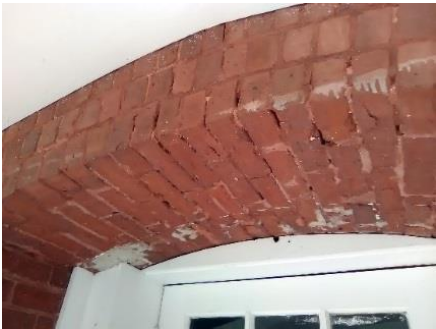
Image 72, Sub-Basement Arch

Deteriorated mortar is apparent at many locations at brick and stone masonry. Most significant is visible along the north and west elevations.

- When excessive moisture can enter a wall and freeze repeatedly, spalling of the mortar and brick will occur due to the expansive nature of frozen water. The sources of moisture entry, beyond normal exposure include leaks in flashing, gutters, lintels, sills and sealant joints.
- Built without adequate expansion joints. Cracking can occur from building movement, thermal expansion. All clay products (brick) grow in long term service while concrete products shrink.
- Uneven settlement in a building's foundation may occur resulting in cracking.
- The composition of the mortar used may be such that it is unable to be as resistant to severe weathering.
- Erosion from water, wind and pollution.

A. Spalled bricks, missing mortar at arched entrance at the sub-basement (Image 72).

Recommend pointing in areas where missing mortar is present. New mortar shall match existing color and thickness. Joints between granite stairs should be professionally inspected, if the sealant has torn or lost elasticity than existing material should be removed, with new sealant installed.

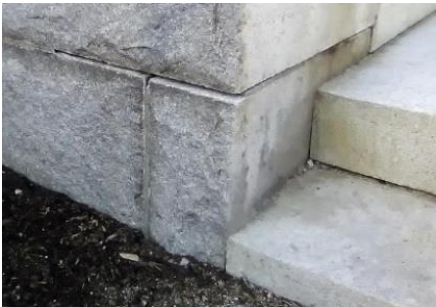
Image 73, South Granite Step

B. Mortar missing west of granite steps at south elevation (Image 73).

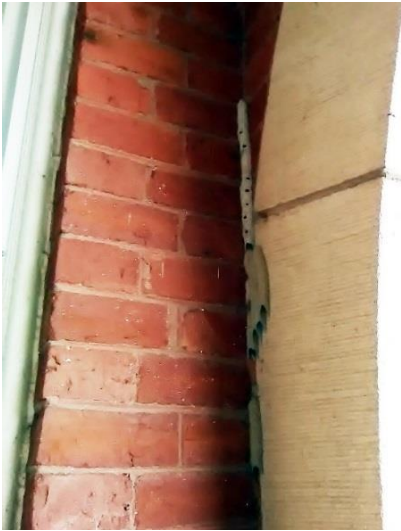
Image 79, Mud wasp nest

Spider webs, wasp nests, and vegetative growth are present at many locations.

- A. Mud wasp nests and spider webs were visible at entrances and overhangs (Images 79).

Recommend these areas of buildup of organic matter should be removed and cleaned to present a more pleasant appearance.

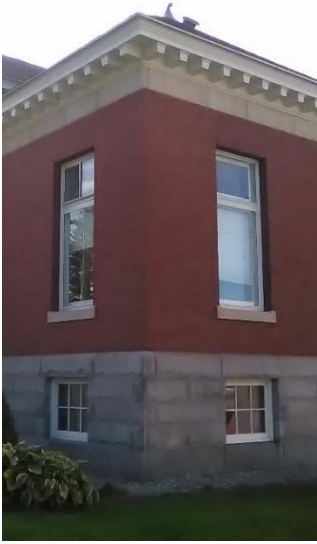
Image 84, Main level and lower level

The original main level monumental fixed wood windows are in good condition. Their upper operable wood awning leaded windows are in very good condition and properly function with original hardware.

Lower level E-Room wood single hung windows are not original and longer function correctly. They include aluminum storm windows installed to the exterior side (Image 84). Existing windows are not well insulated and should be removed, repaired, and reinstalled with adequate perimeter insulation.

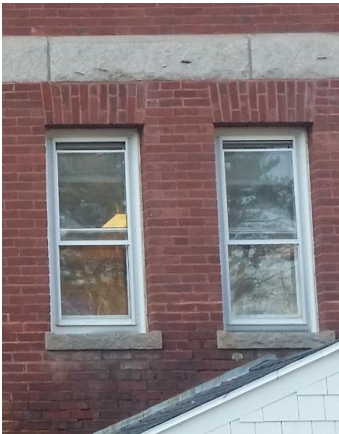
Image 85, E-Room windows

Lower level fixed wood window sashes and muntins are in fair condition, many of the original panes are damaged and or replaced with assorted glass. Some glazing panes appear to be original, the non-historic glass should be removed and restored with period glazing.

Repair existing glazing. Replace in kind

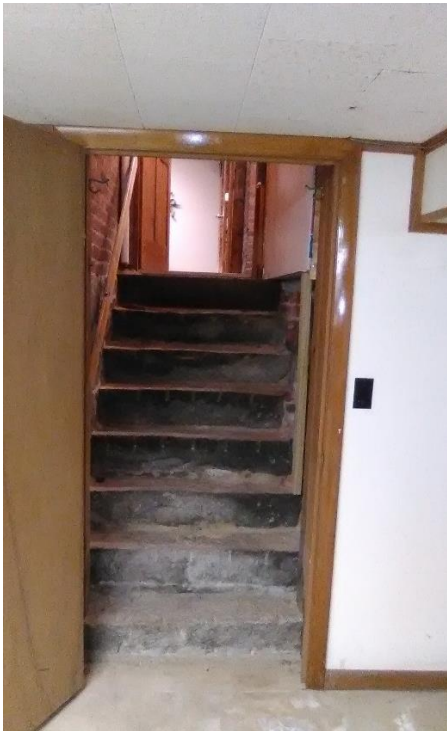
Image 89, Sub-basement stair to J-room

The lowest level sub-basement has evidence of water infiltration. Potentially through the stacked stone foundation. The lack of ventilation in the space along with moisture have created a damp environment and musty smell.

Recommend engaging an environmental testing agent to inspect and remediate the issue. There are various methods of correcting foundation water issues. Exterior perimeter drainage and sloping grade are first steps. Exterior mortar joint repair with proper flashing along with treatment of the interior face of stone with a membrane should be considered.

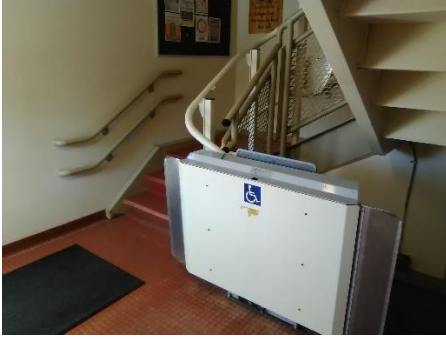
Image 90, Garaventa chair lift #1

The lower level consists of multiple rooms at two different floor heights. The E-Room is adjacent to the egress stair and accessible by way of the Garaventa Chair Lift (Image 90) which has surpassed its functional lifespan. Access to the meeting room, ADA bathroom and the juvenile “J-room” are lower still, accessed by way of a short stair or a small vertical lift. (Image 91)

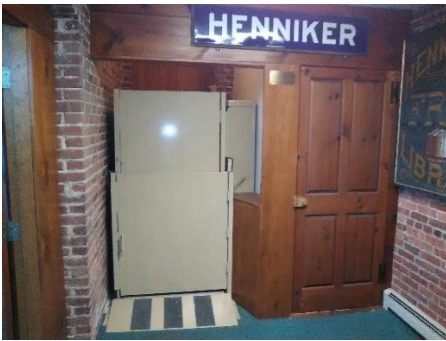
Image 91, Vertical lift #2

Functionally speaking these level separations are not optimal for a public library. Combined with the challenges for patrons who require assistance using both lifts to access the facilities only accessible restroom makes this the most important issue to rectify.

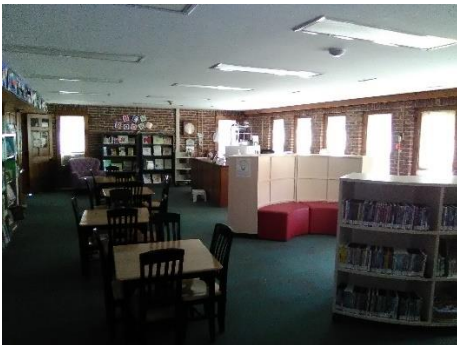
Image 92, E-Room, 1978 floor, note the low ceiling

Historically there have always been two levels, one space having a much higher ceiling. In 1978 an intermediate floor was added to divide this high space to create two separate rooms. (Image 92)

In general, the exposed masonry walls, gypsum ceilings, floors, and simple trim are in good condition. Lighting consists of a mix of incandescent and fluorescent. At the time of this report was planned to be retrofitted with high efficiency LED lamps.

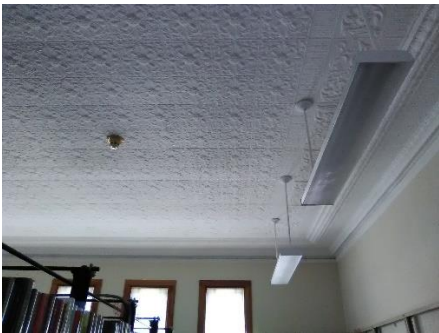
Image 94, Tin ceiling with pendant florescent lighting fixtures

Lighting varies throughout at the time of this report a plan to retrofit the existing fixtures with high efficiency LED lamps was in place. (Image 94)

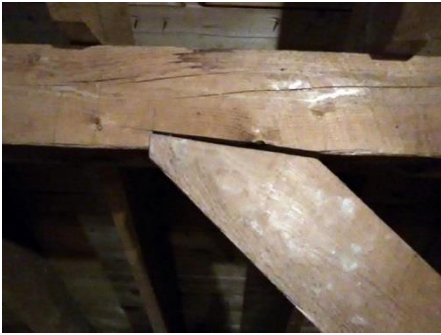
Image 96, Gap at truss

- A. Heavy timber roof trusses in a couple locations are separated at the compression joints. (Image 96).
- B. Wood floorboards are slightly damaged; possibly done they were removed to add below-floor insulation. (Image 97)
- C. Daylight was visible through flashing adjacent to the chimney (Image 98).
- D. Minor signs of water infiltration present at the stair landing, roof boards adjacent to the brick knee wall.
